Manhole Inspection Summary

Manhole # S47C__039MH

Insp Date: **7/10/08 1:28 PM**

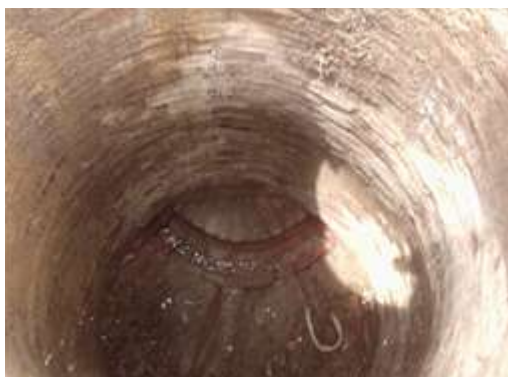
Defect 1

Condition: ☐ Sound ☐ Cracked ☐ Root Intrusion ☒ **Loose Brick** ☐ Deteriorated

deterioration

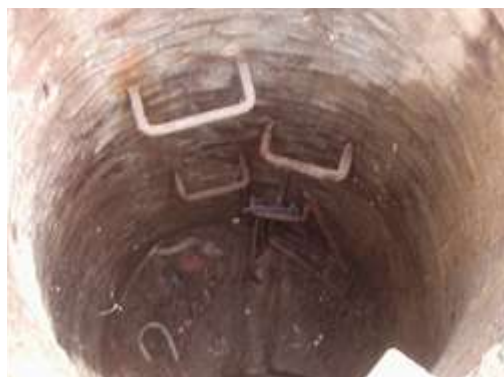
Defect 2

Infiltration: ☐ None ☒ **Joint** ☐ Cracks ☒ **Mortar** ☐ Roots ☐ Wall

infiltration

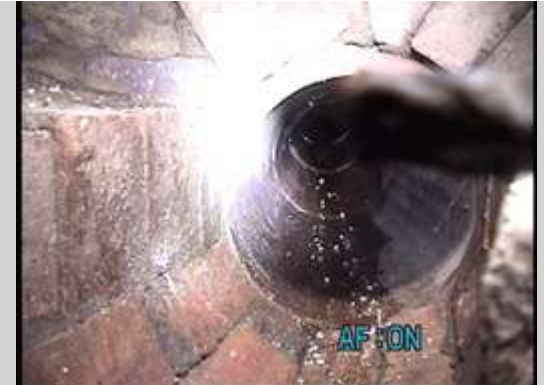
12 O'Clock Outflow

8 in. Circular Gravity Sewer
Pipe Out @ 12 O'Clock

Pipe Height: **8.4** (in.) Rod and Bar (Angled)
Pipe Material: **Clay** ☐ Pipe Lined
Invert Depth: **9.35** (ft.) Flow Characteristics: **Slow**
Deposits: ☒ None ☐ Mud ☐ Sludge ☐ Debris ☐ Grease
Silt Depth: (in.) Deposits Extent:
Infiltration: **None** Pipe Seal Cond: **Sound**

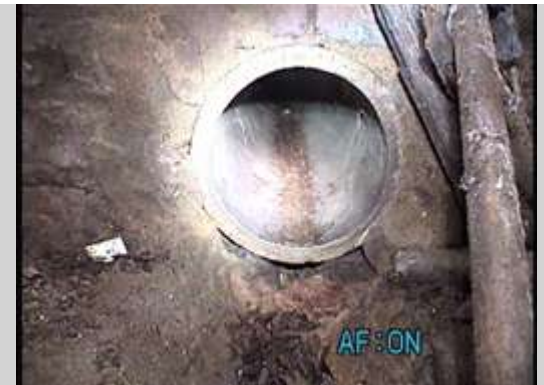
5 O'Clock Inflow

6 in. Circular Gravity Sewer
Pipe In @ 5 O'Clock

Pipe Height: **6** (in.) Rod and Bar (Angled)
Pipe Material: **Clay** ☐ Pipe Lined
Invert Depth: **8.45** (ft.) Flow Characteristics: **None**
Deposits: ☒ None ☐ Mud ☐ Sludge ☐ Debris ☐ Grease
Silt Depth: (in.) Deposits Extent:
Infiltration: **None** Pipe Seal Cond: **Sound**

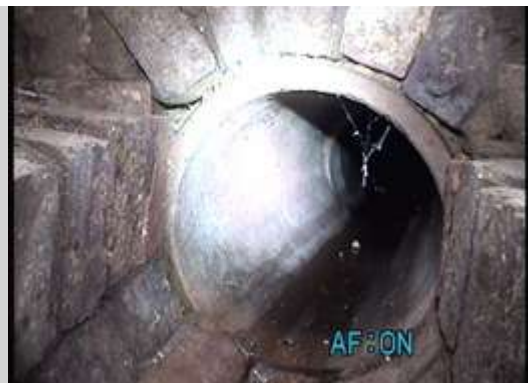
9 O'Clock Inflow

8 in. Circular Gravity Sewer

Pipe In @ 9 O'Clock

Infiltration: **None** Pipe Seal Cond: **Sound**
